## CASE STUDY

CLIENT: North American  
Iron Ore Mine

PROJECT: Vibrating Screen  
Discharge Chute Loaf Liners

## Domite Cast Chrome White Iron Loaf Liners Extend Wear Life

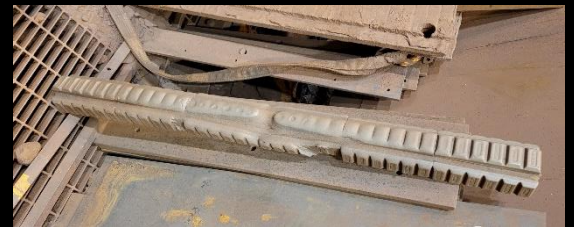
The center wall cast liners in a vibrating screen discharge chute, sometimes in-between repair cycles, were wearing out causing damage to the chromium carbide overlay plate wall underneath.

Old liner after one 20-week repair cycle

Domite loaf liners were installed to protect the center CCO wall from wear and delamination.

The old-style cast liners would wear out during one 20-week repair cycle. The Domite loaf liners are onto their second 20-week repair cycle showing minimal wear.

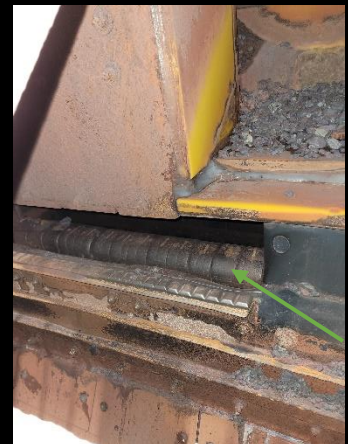
Domite loaf liners during their second 20-week repair cycle
